**REPORT:** FE-02-97

**RAILROAD:** Union Pacific Railroad Company (UP)

**LOCATION:** South Fontana, California

**PROBABLE CAUSE:** The Conductor lost his grip during a shoving move and fell in front of the lead car.

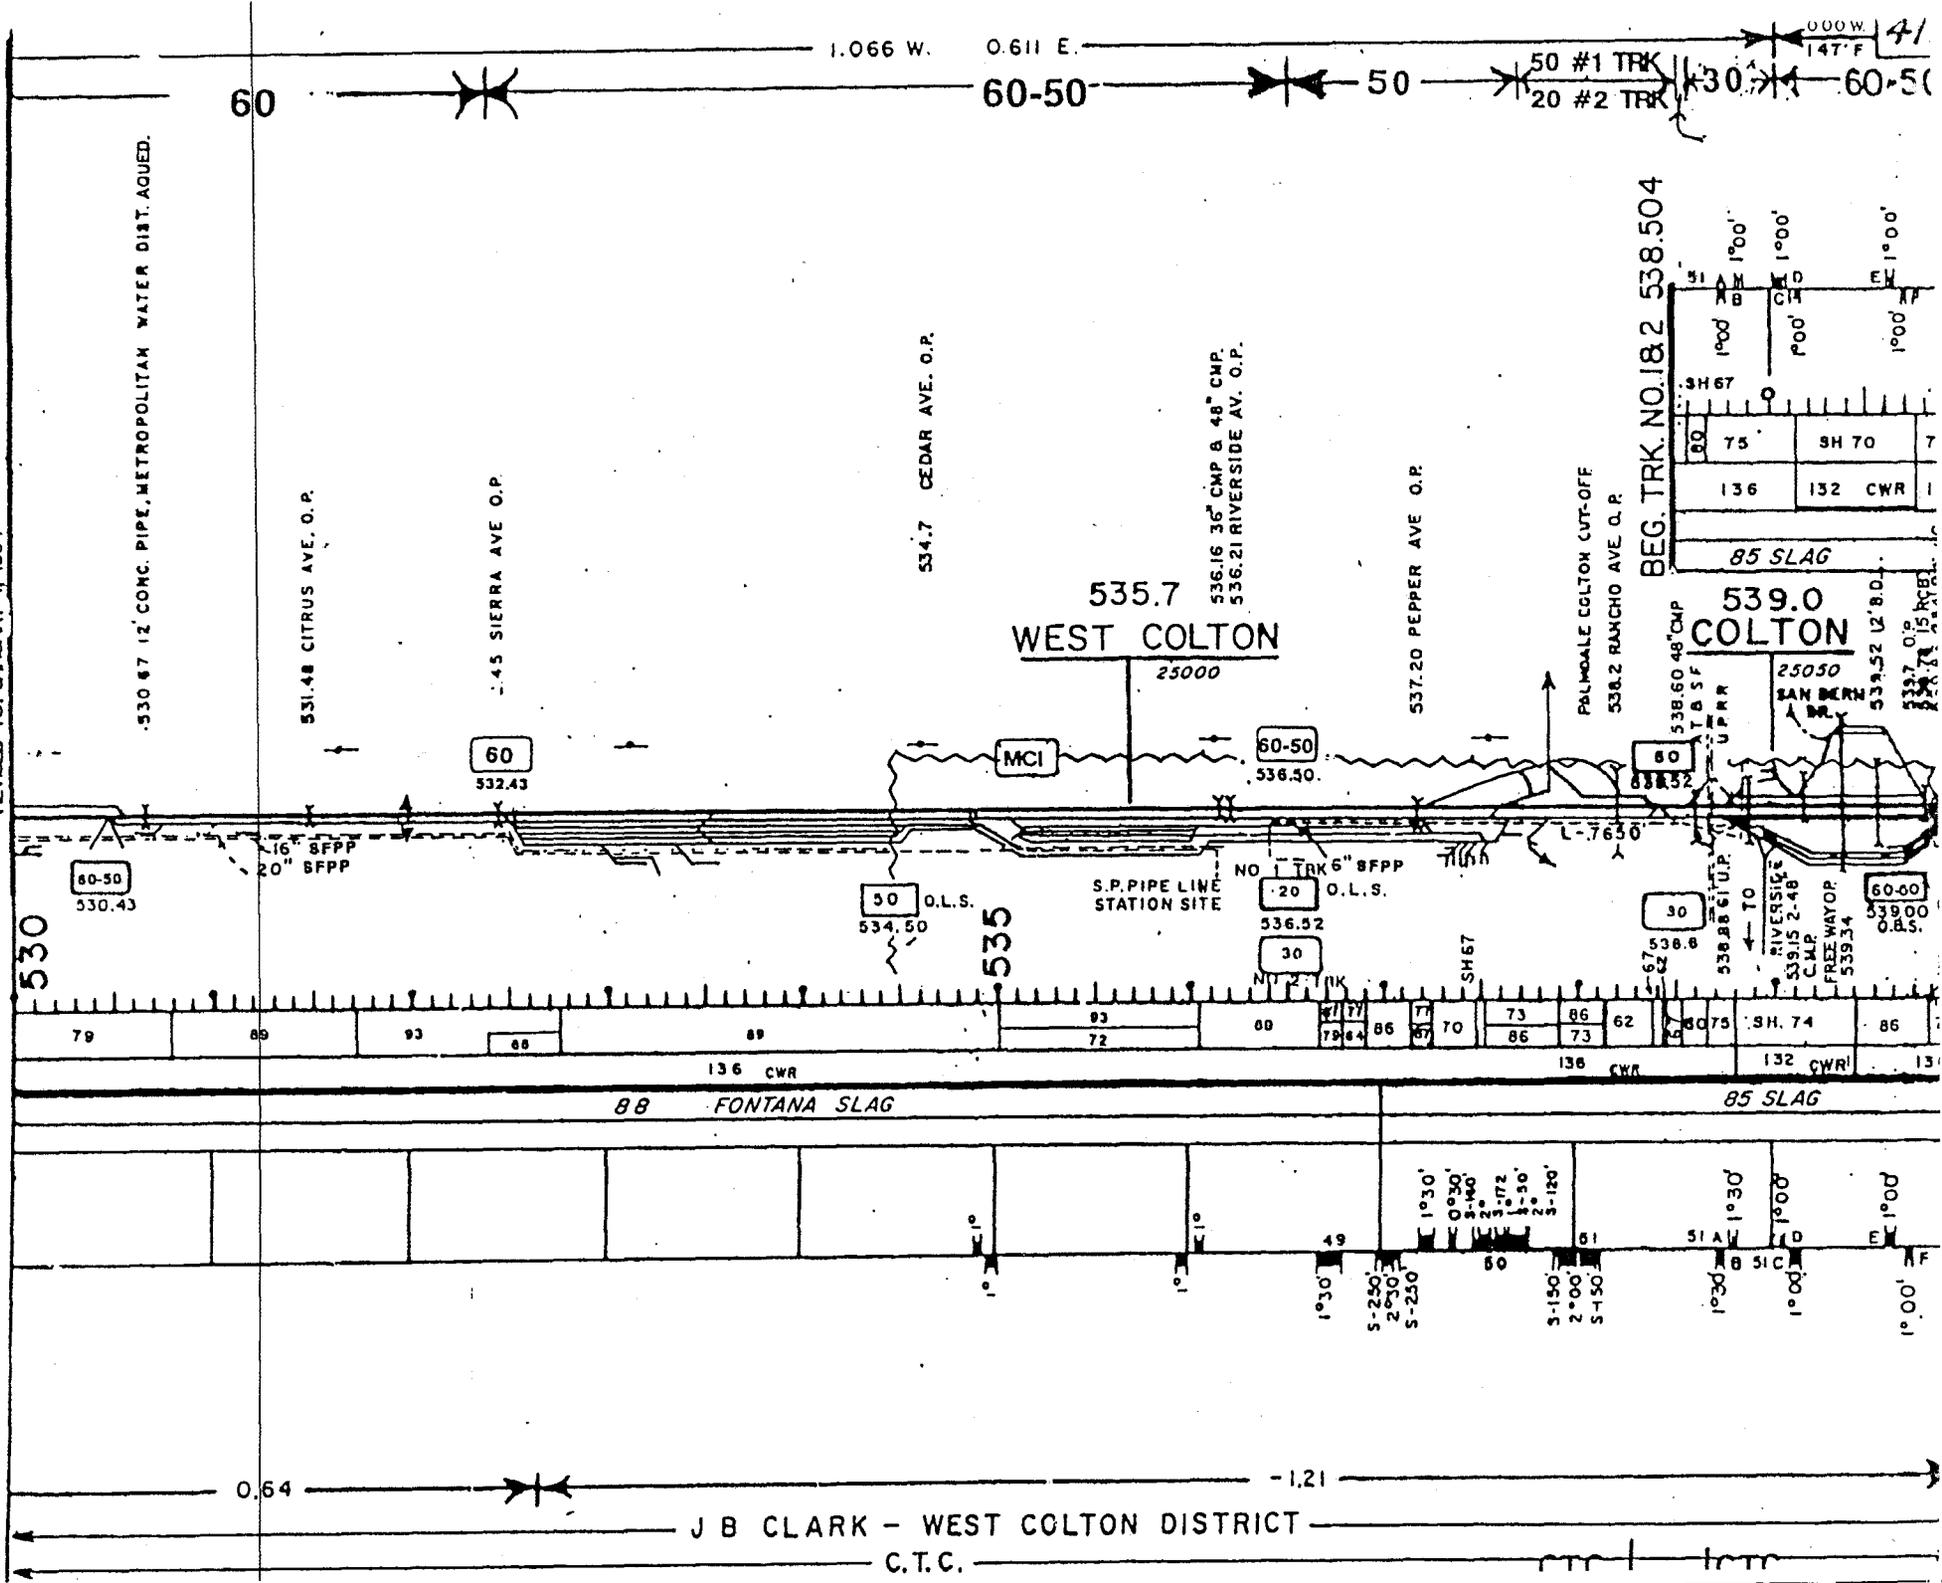
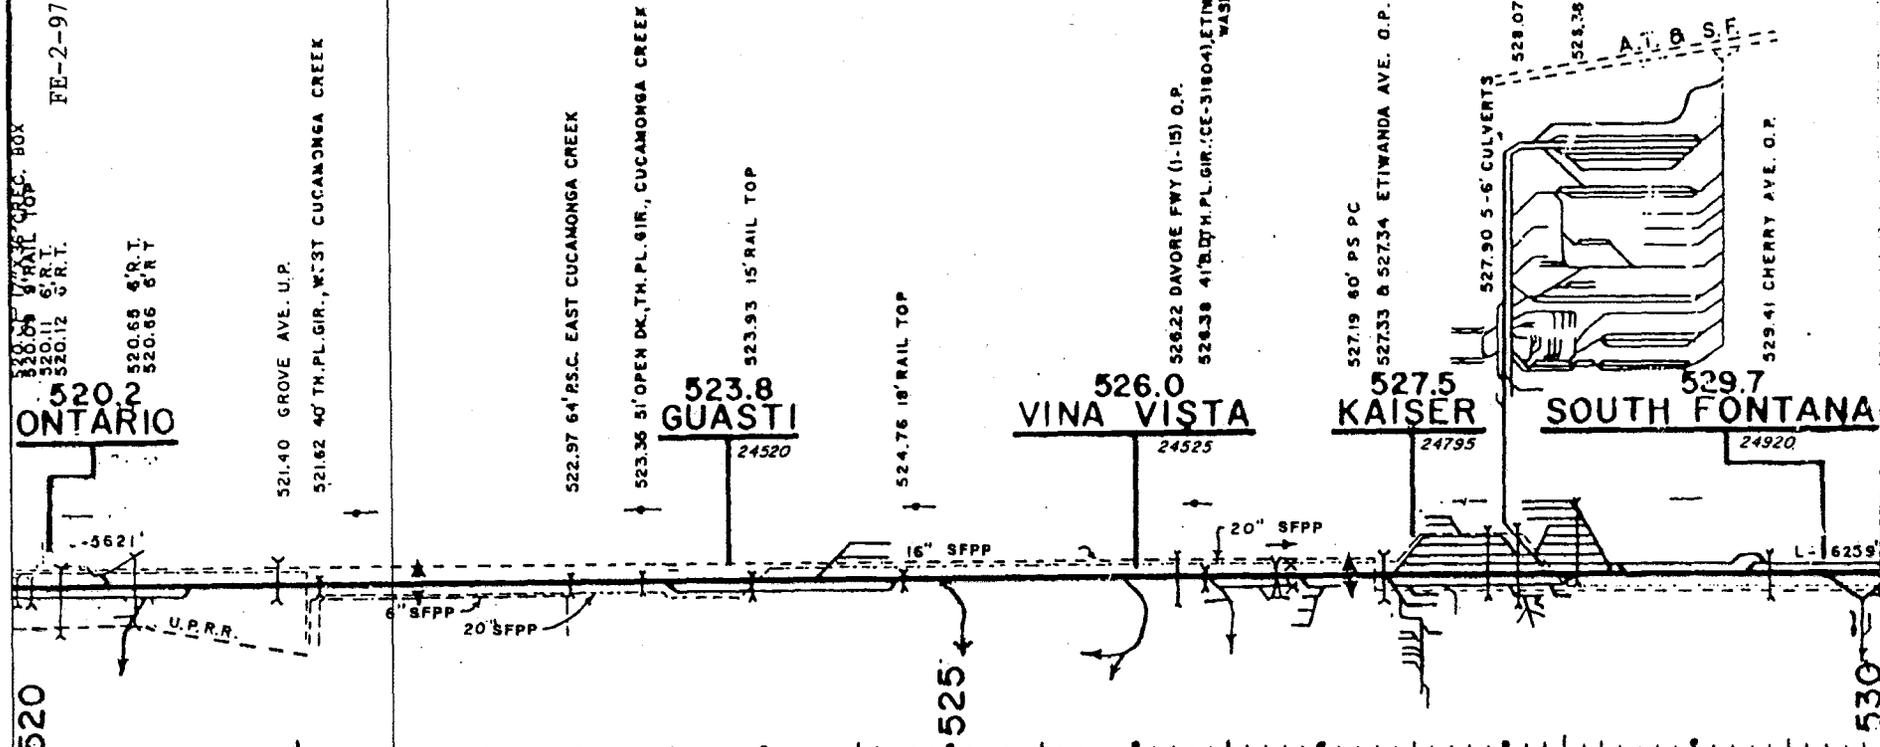
J B CLARK - WEST COLTON DISTRICT  
C.T.C.

The locomotive consist then re-entered the east end of the siding to couple to the rear of the train, allowing the locomotives to push the train into the Kaiser Steel Plant. The South Fontana siding had a westward descending grade of 0.64 percent.

were 'stretched' or in draft position. When the westward shoving move occurred, the drawbars and couplers of the cars began to 'bunch' into buff position. The Engineer said he was using the independent brake to control the speed of the train. While making the shoving move, the Engineer applied the independent locomotive brake, which caused the drawbars and couplers to change rapidly from buff to draft, causing a violent surging movement. The Conductor lost his grip at this point and was projected forward, falling in front of the wheels of the lead car.
